***"Reflective distortion Issue reported on D471 Rear Doors
and Front Doors Tempered Glass"***

**Monografía presentada para obtener el título de:
Ing. Industrial en procesos y servicios**

Monografía sometida a la Escuela de Ingeniería
Industrial de la
Universidad Vasco de Quiroga

07 de Abril del 2009

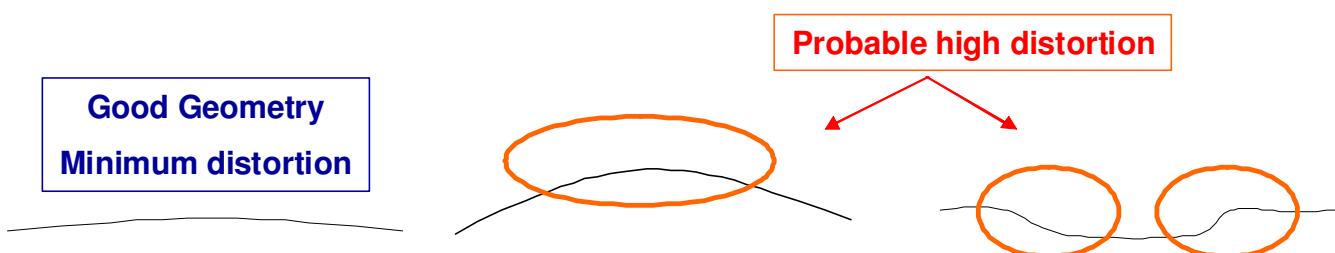
This cause is considered the main contributor of Reflective Distortion on the D471 Rear Door and Front Door. The reason is that according to Drawing the FORM tolerances for top edge is $+0/-2\text{mm}$ and for all other edges the tolerance is $\pm 1.0 \text{ mm}$. This means that we can have a glass on the maximum tolerance $+1.0 \text{ mm}$ on each of the pillars and then a transition to the top edge to the minimum -2 mm a whole of 3.0 mm of distance between pillars and top edge.

The glass tends to reflect distortion on areas where there is an irregular surface/geometry:

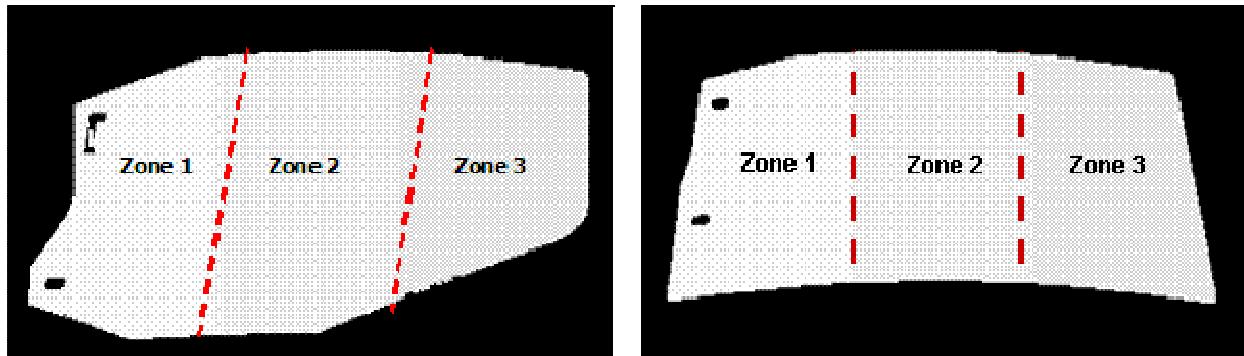
According to the pictures from Issue reported by Ford Plant, the zone 3 seems to be the one with Reflective Distortion issues, so it should reflects the highest value on all studies.

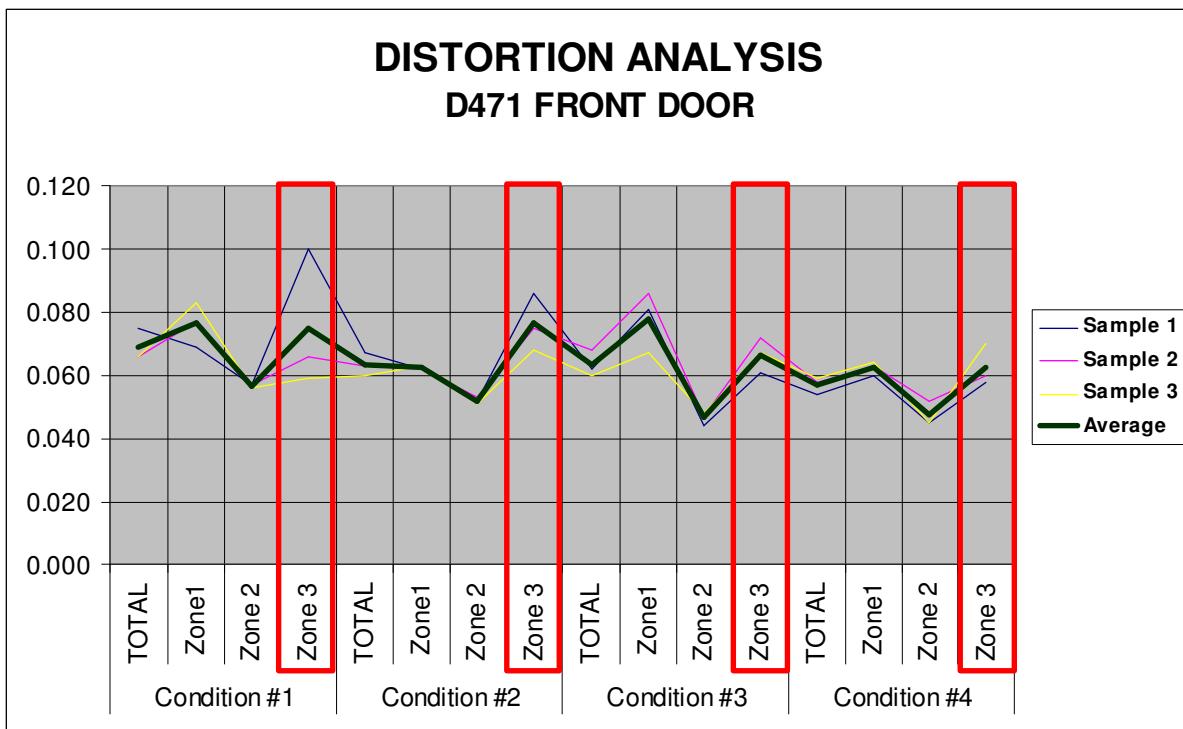
Summarizing the DA readings on chart, the results are as follows:

The samples under conditions 3 & 4 are the ones that gives the best distortion results, which also is shown on the images generated from the CMM data, seen before.

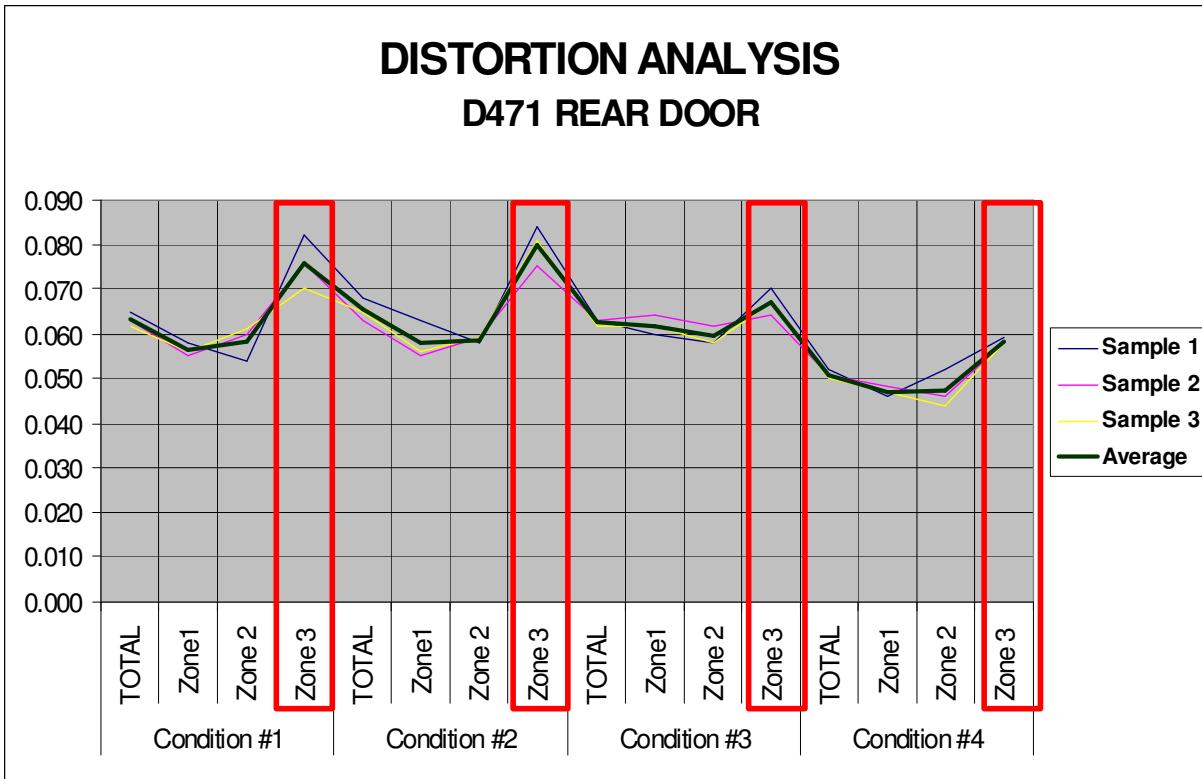
Summarizing the DA readings on chart, the results are as follows:

The samples under conditions 3 & 4 are the ones that gives the best distortion results, same that happened on D471 Front Door, which also is shown on the images generated from the CMM data, seen before.

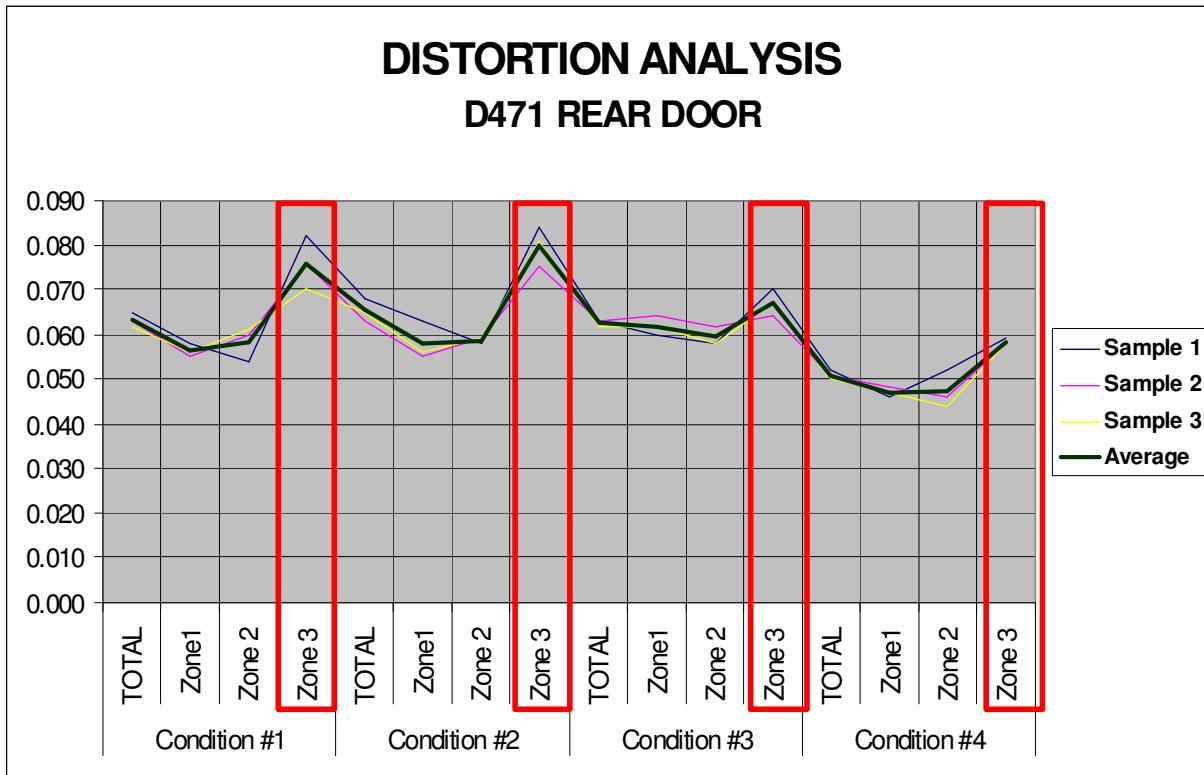
Como se puede ver, con cada una de las mejoras o cambios realizados se fue obteniendo un mejor desempeño en Distorsión expresado en un valor numérico. Siendo la condición número 4 la que mejor resultados ópticos presentó en estas puertas traseras analizadas.

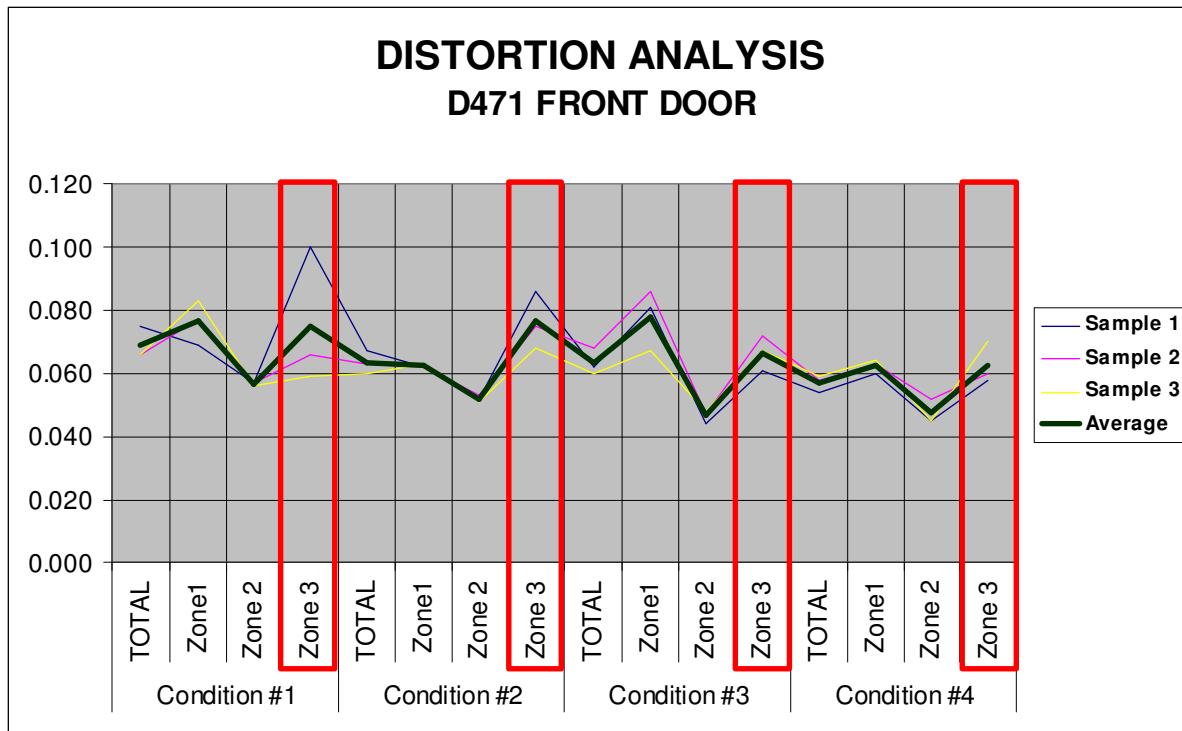
Como se puede ver, al igual que con las Puertas Traseras, con cada una de las mejoras o cambios realizados se fue obteniendo un mejor desempeño en Distorsión expresado en un valor numérico. Siendo la condición número 4 la que mejor resultados ópticos presentó.

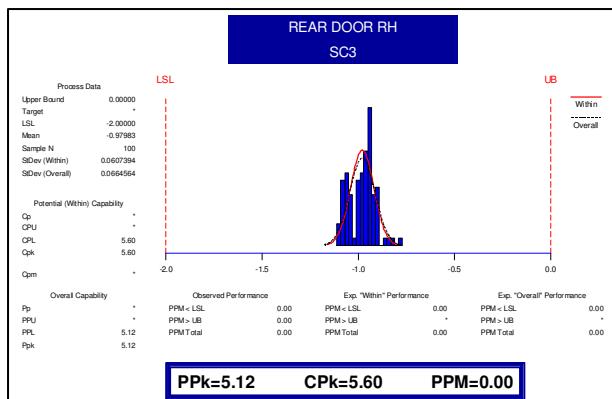
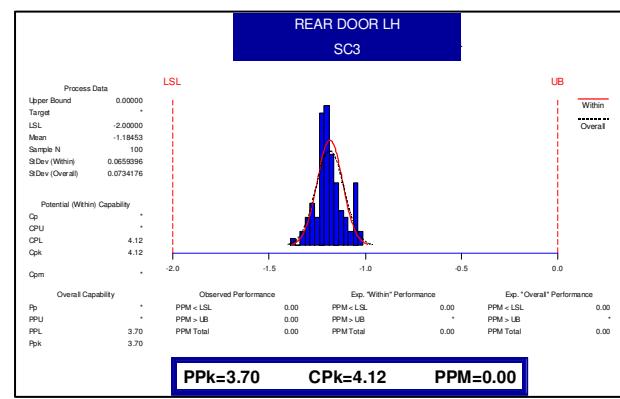
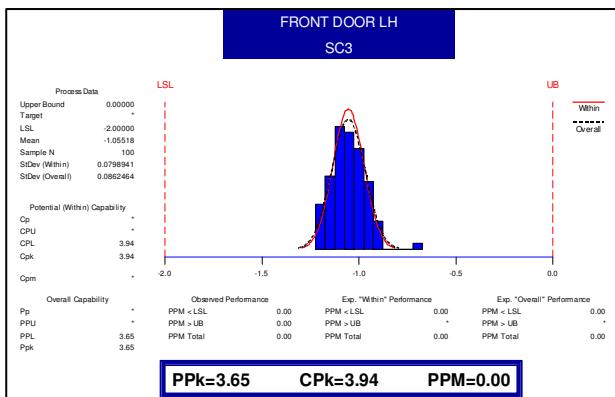
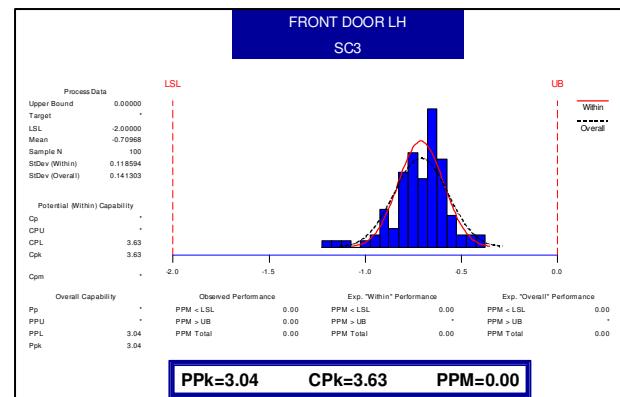
Debido a que en el canto superior nuestra habilidad de proceso inicial (PPk) no cumplía por las situaciones ya mencionadas en el Capítulo de Desarrollo, al momento de obtenerse un solo punto marcado como Característica Especial a controlar estadísticamente, se lograron obtener los siguientes resultados:

Una habilidad de proceso (PPk's) muy por encima del 1.67 mínimo requerido para tener una confiabilidad en el proceso en cuanto a defectivos se refiere.
