***"Reflective distortion Issue reported on D471 Rear Doors
and Front Doors Tempered Glass"***

**Monografía presentada para obtener el título de:
Ing. Industrial en procesos y servicios**

Monografía sometida a la Escuela de Ingeniería
Industrial de la
Universidad Vasco de Quiroga

07 de Abril del 2009

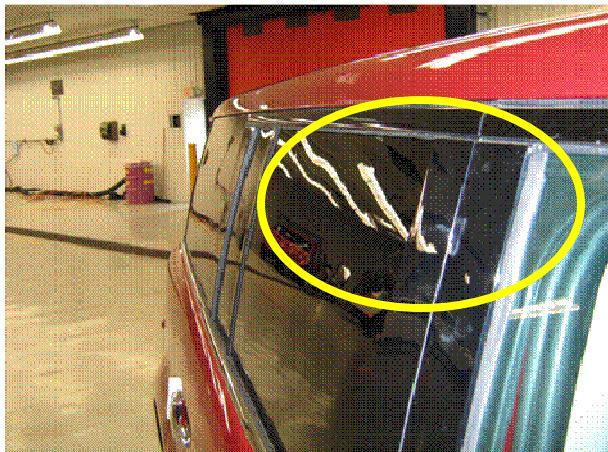
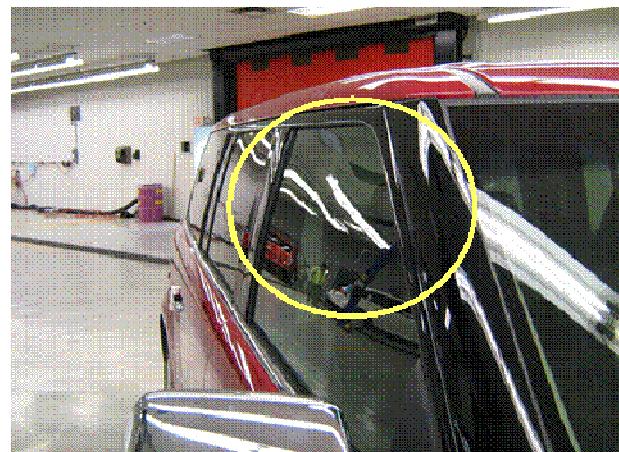
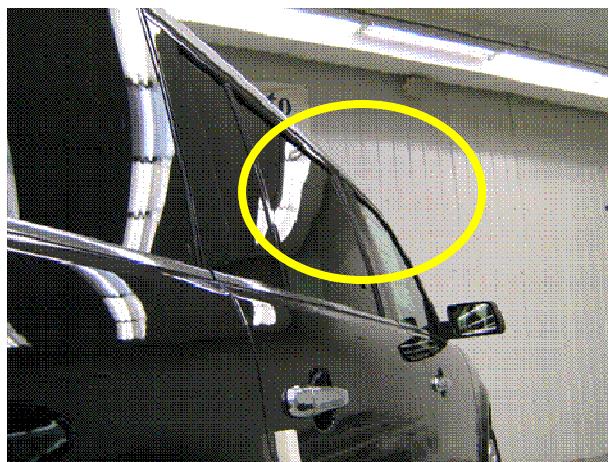
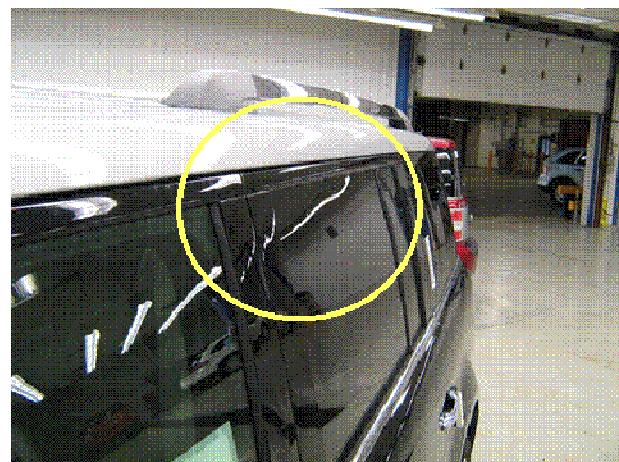
REFLECTIVE DISTORTION REPORTED

Vitro Flex was penalized by a Ford Assembly Plant because during TT BUILD of New Project D471 Rear Doors and Front Doors they appeared wavy/distorted during final inspection on units.

Ford Assembly Plant reported all door glass appears wavy/distorted

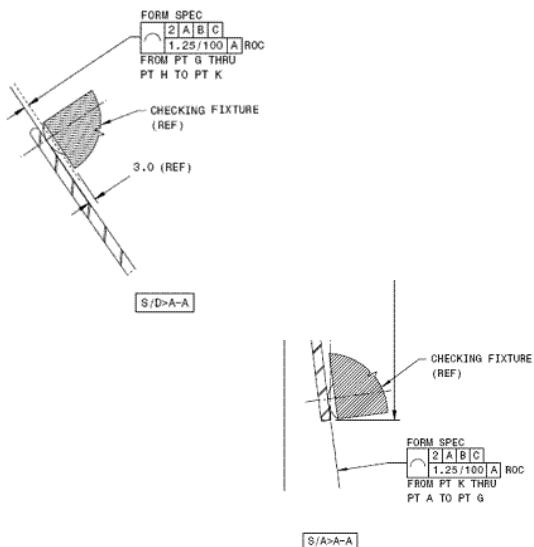
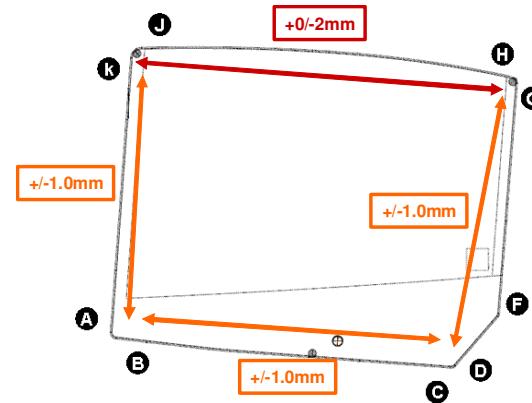
REAR DOOR GLASS: FORM SPECIFICATION

This cause is considered the main contributor of Reflective Distortion on the D471 Rear Door and Front Door. The reason is that according to Drawing the FORM tolerances for top edge is $+0/-2\text{mm}$ and for all other edges the tolerance is $\pm 1.0 \text{ mm}$. This means that we can have a glass on the maximum tolerance $+1.0 \text{ mm}$ on each of the pillars and then a transition to the top edge to the minimum -2 mm a whole of 3.0 mm of distance between pillars and top edge.

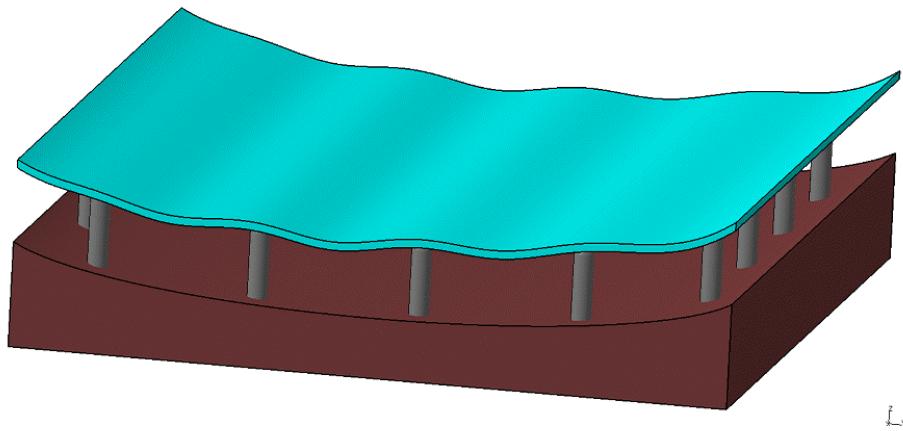
Next image simulates the glass being curved on a bending fixture with screws every 2":

The result we want to have by adding screws every 1" can be seen on next image. The glass is been curved softly so curvature can be controlled with more precision.

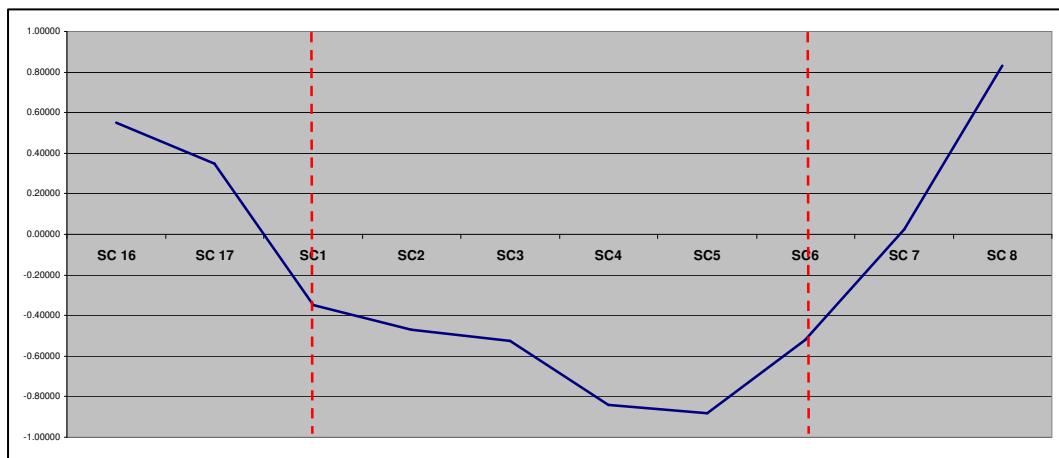
D471 FRONT DOOR RIGHT HAND (TOP EDGE)

The next charts shows the behavior of transition between Bilateral tolerances to Unilateral for Front Doors Left hand and Right hand and Rear Doors as well.

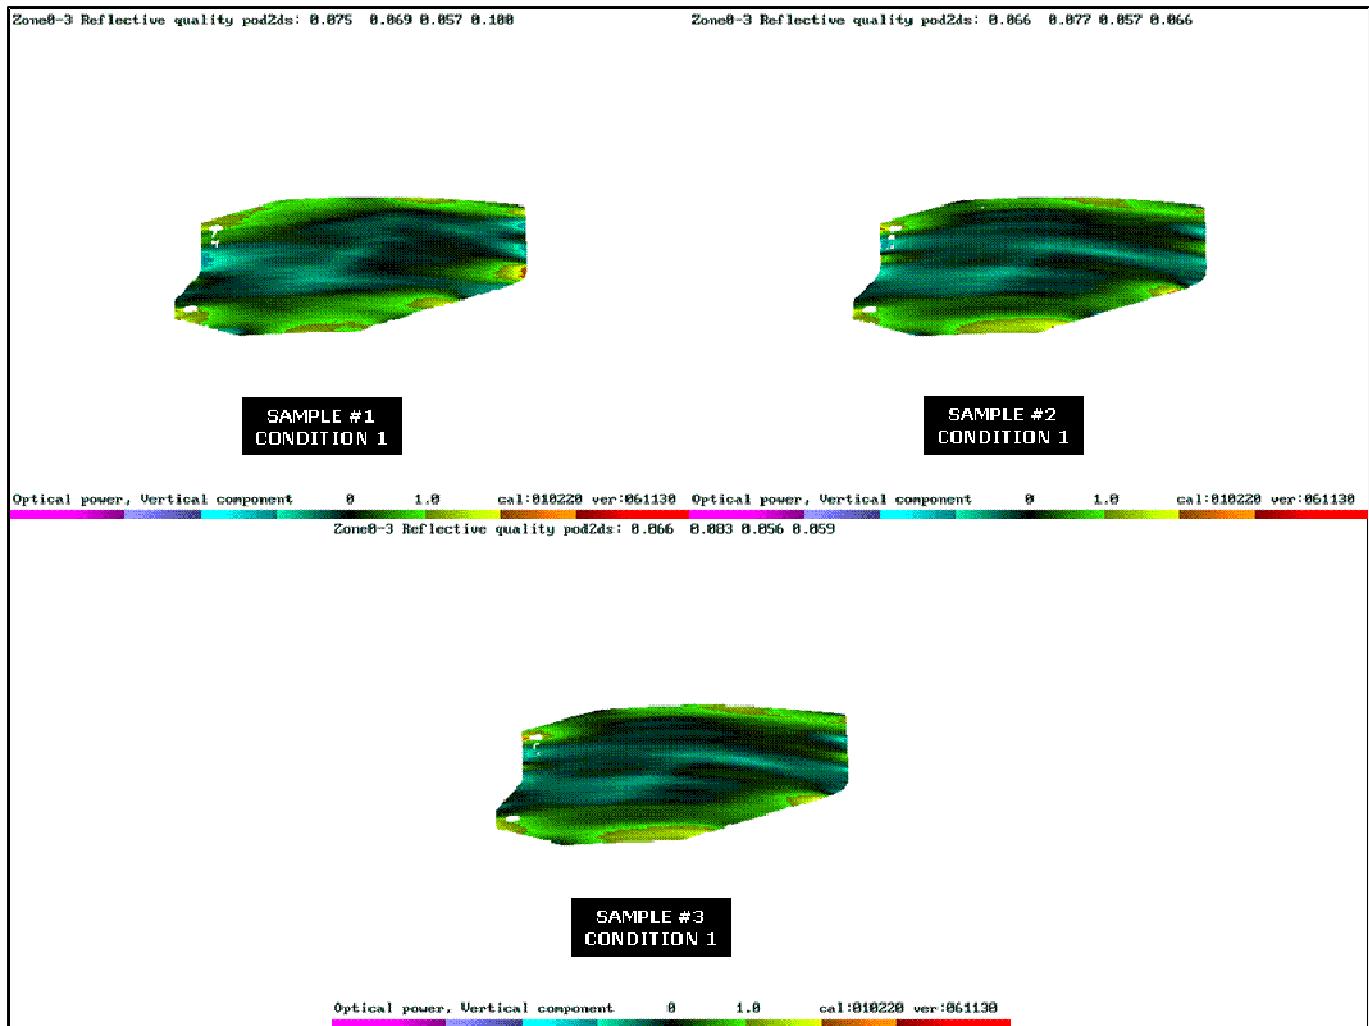
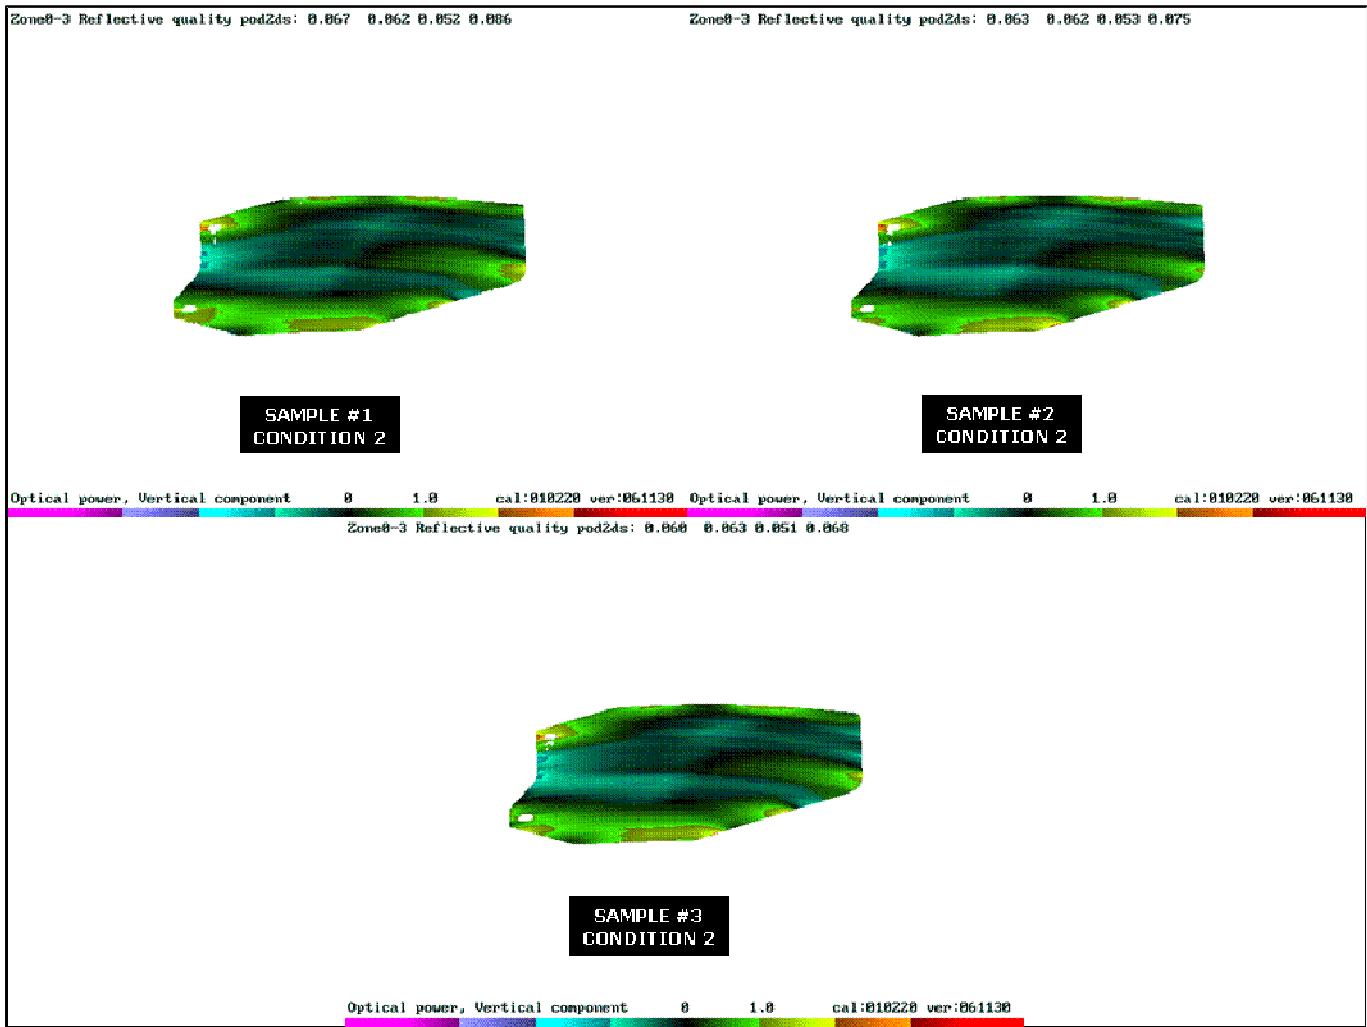
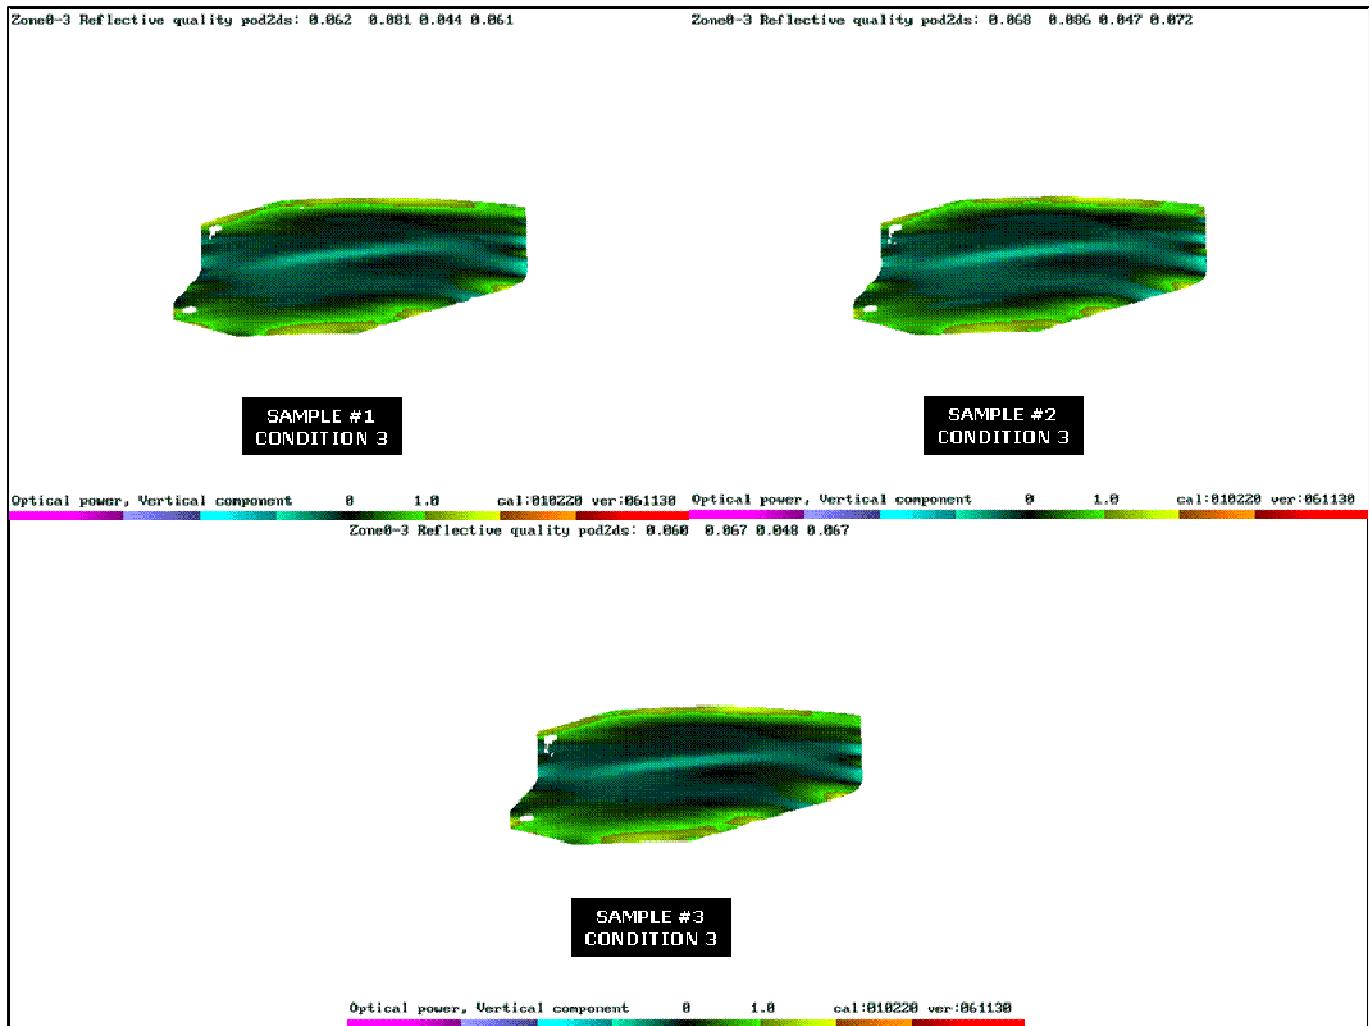
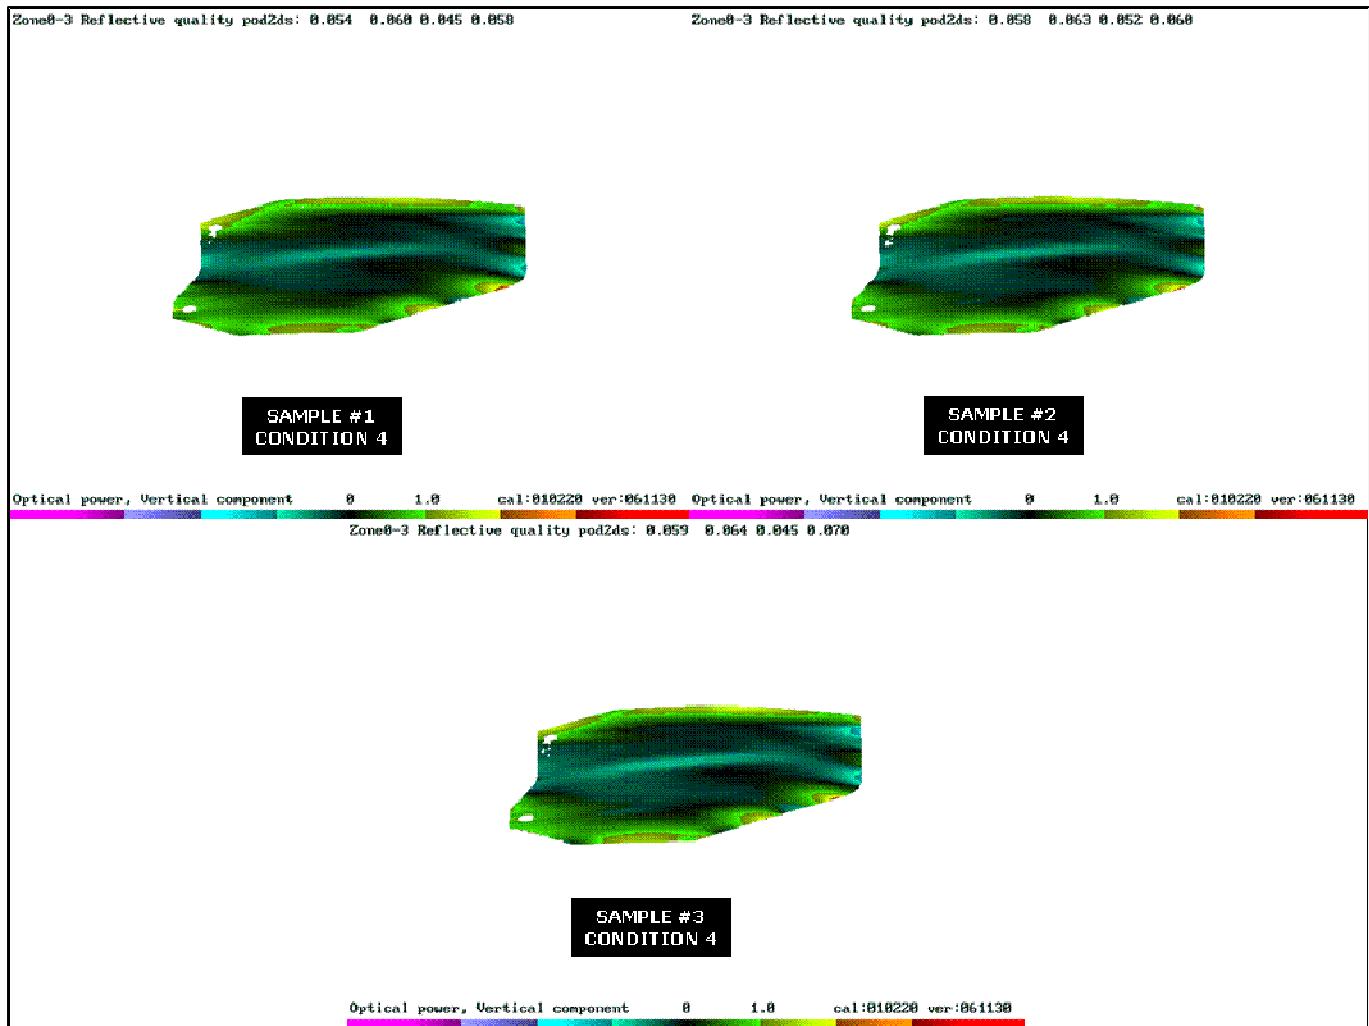
FRONT DOOR DISTORSION ANALYSIS READINGS

Condition #1			
	TOTAL	Zone1	Zone 2	Zone 3
Sample 1	0.075	0.069	0.057	0.100
Sample 2	0.066	0.077	0.057	0.066
Sample 3	0.066	0.083	0.056	0.059
Average	0.069	0.076	0.057	0.075

Condition #2			
	TOTAL	Zone1	Zone 2	Zone 3
Sample 1	0.067	0.062	0.052	0.086
Sample 2	0.063	0.062	0.053	0.075
Sample 3	0.060	0.063	0.051	0.068
Average	0.063	0.062	0.052	0.076

Condition #3			
	TOTAL	Zone1	Zone 2	Zone 3
Sample 1	0.062	0.081	0.044	0.061
Sample 2	0.068	0.086	0.047	0.072
Sample 3	0.060	0.067	0.048	0.067
Average	0.063	0.078	0.046	0.067

Condition #4			
	TOTAL	Zone1	Zone 2	Zone 3
Sample 1	0.054	0.060	0.045	0.058
Sample 2	0.058	0.063	0.052	0.060
Sample 3	0.059	0.064	0.045	0.070
Average	0.057	0.062	0.047	0.063

The samples under conditions 3 & 4 are the ones that gives the best distortion results, which also is shown on the images generated from the CMM data, seen before.

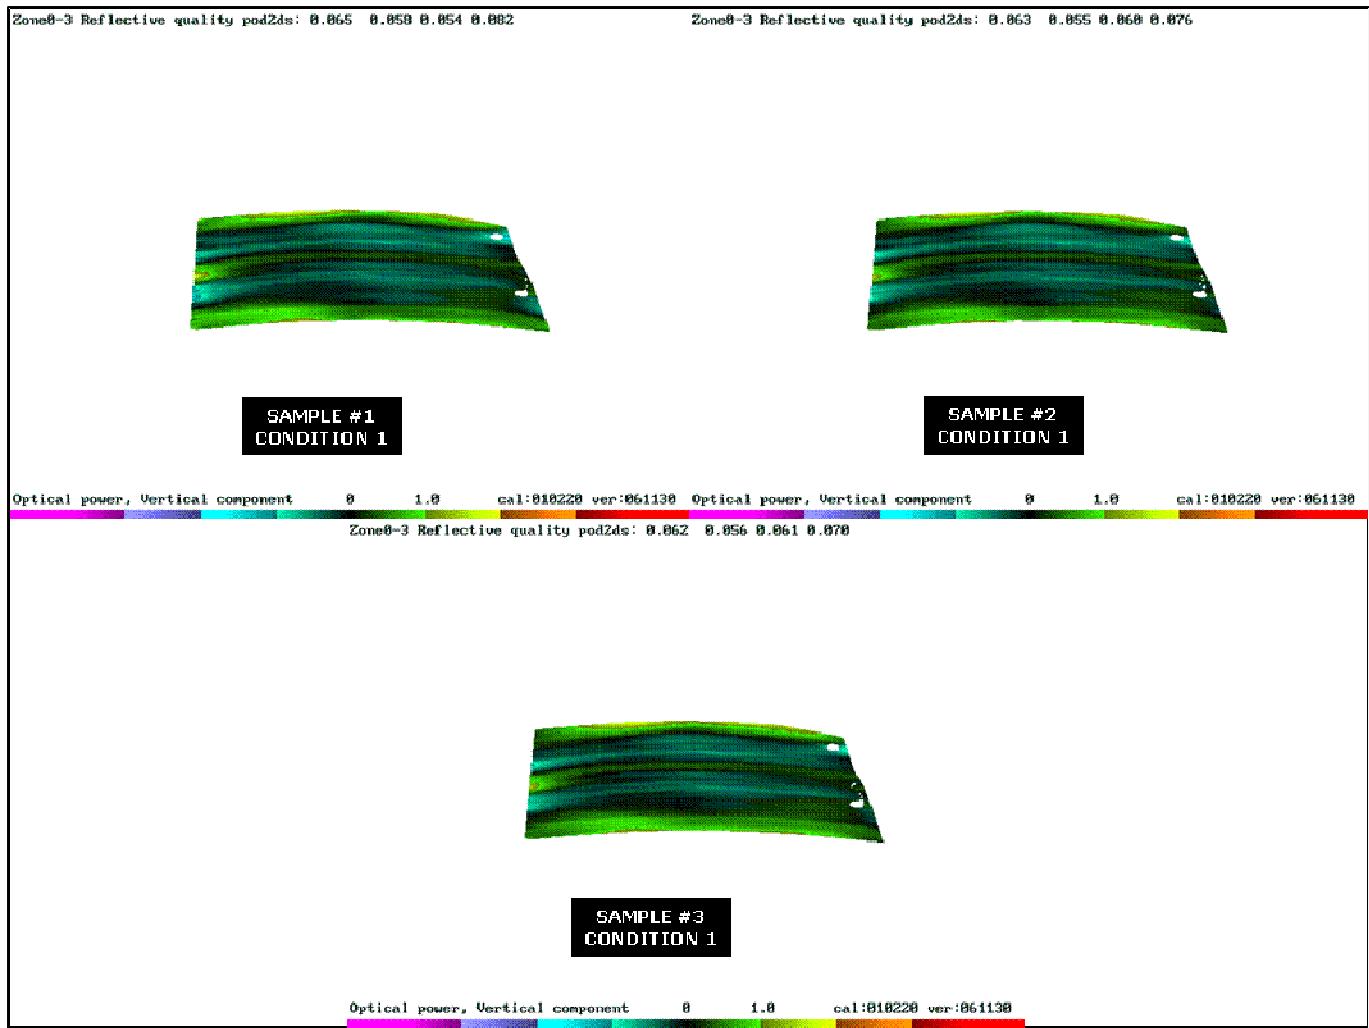
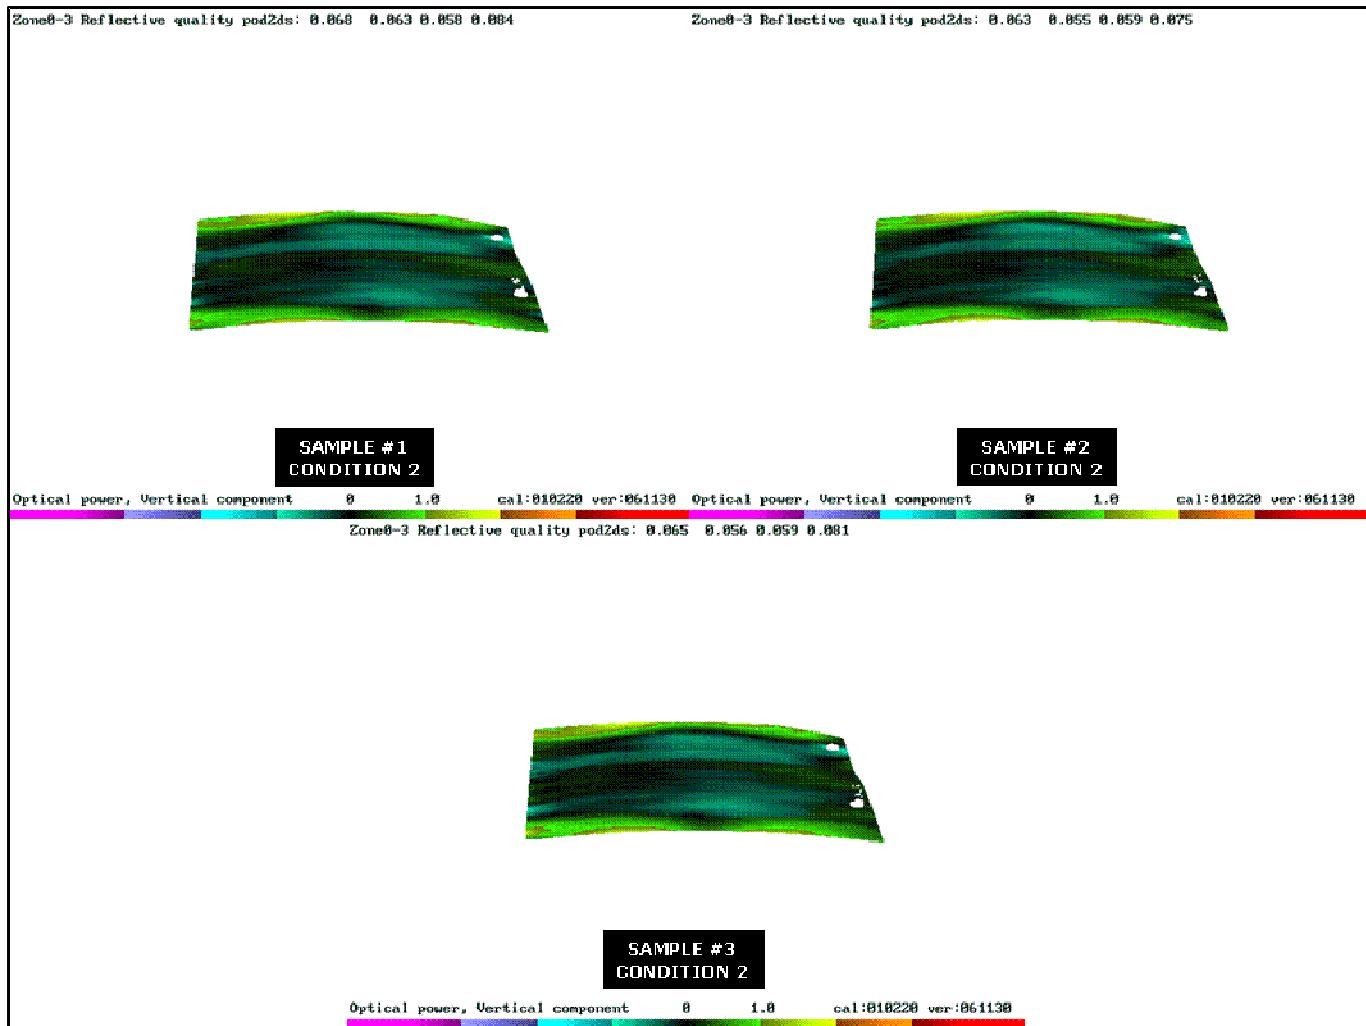
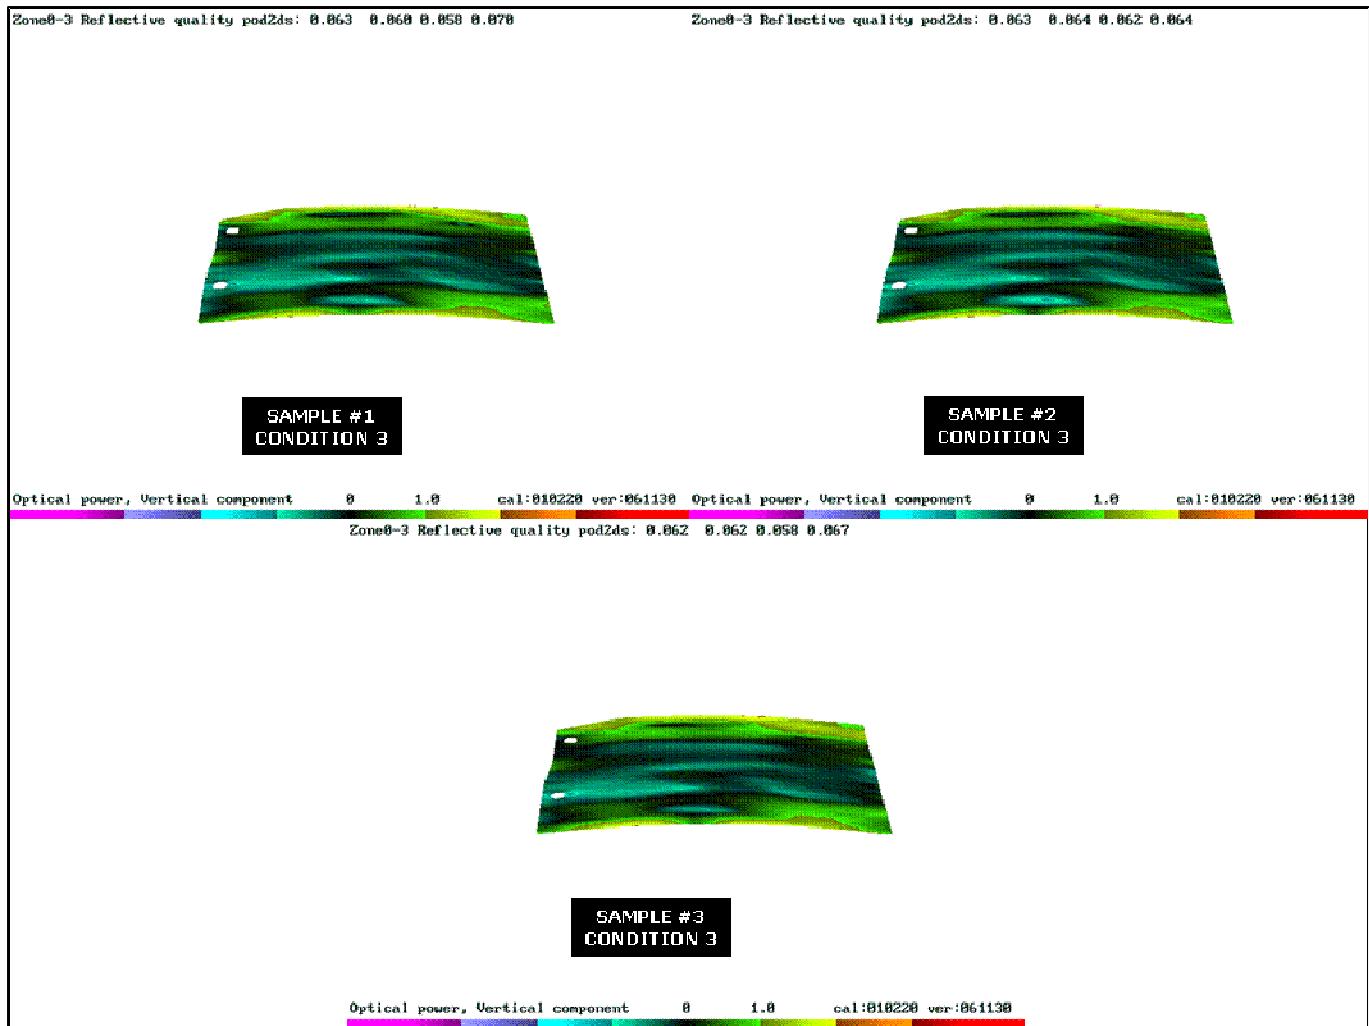
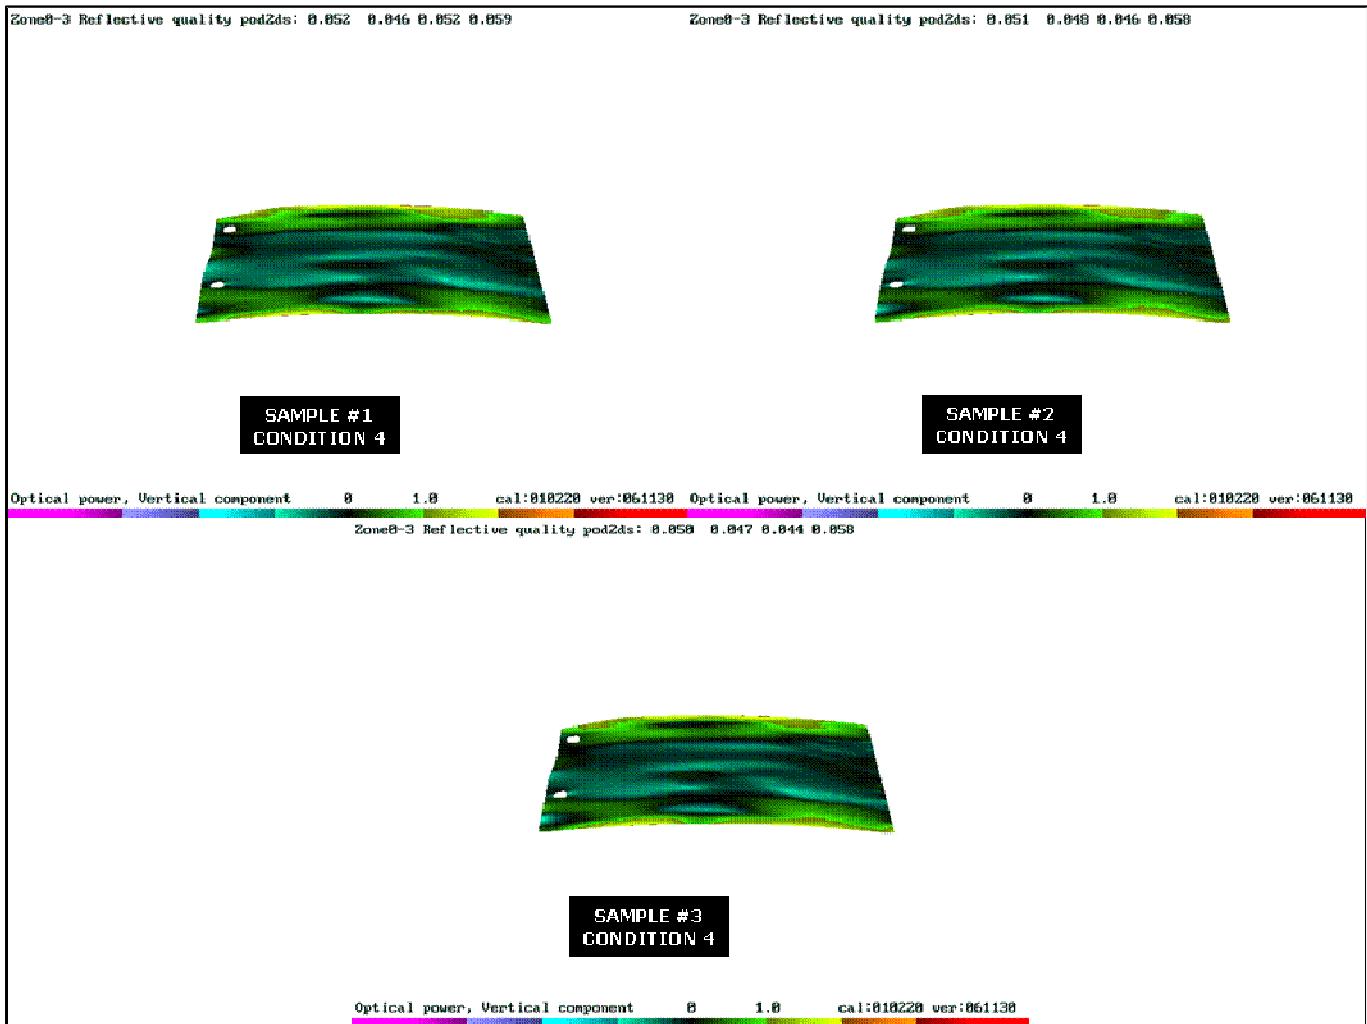
REAR DOOR DISTORSION ANALYSIS READINGS

Condition #1			
	TOTAL	Zone1	Zone 2	Zone 3
Sample 1	0.065	0.058	0.054	0.082
Sample 2	0.063	0.055	0.060	0.076
Sample 3	0.062	0.056	0.061	0.070
Average	0.063	0.056	0.058	0.076

Condition #2			
	TOTAL	Zone1	Zone 2	Zone 3
Sample 1	0.068	0.063	0.058	0.084
Sample 2	0.063	0.055	0.059	0.075
Sample 3	0.065	0.056	0.059	0.081
Average	0.065	0.058	0.059	0.080

Condition #3			
	TOTAL	Zone1	Zone 2	Zone 3
Sample 1	0.063	0.060	0.058	0.070
Sample 2	0.063	0.064	0.062	0.064
Sample 3	0.062	0.062	0.058	0.067
Average	0.063	0.062	0.059	0.067

Condition #4			
	TOTAL	Zone1	Zone 2	Zone 3
Sample 1	0.052	0.046	0.052	0.059
Sample 2	0.051	0.048	0.046	0.058
Sample 3	0.050	0.047	0.044	0.058
Average	0.051	0.047	0.047	0.058

The samples under conditions 3 & 4 are the ones that gives the best distortion results, same that happened on D471 Front Door, which also is shown on the images generated from the CMM data, seen before.
