***"Reflective distortion Issue reported on D471 Rear Doors
and Front Doors Tempered Glass"***

**Monografía presentada para obtener el título de:
Ing. Industrial en procesos y servicios**

Monografía sometida a la Escuela de Ingeniería
Industrial de la
Universidad Vasco de Quiroga

07 de Abril del 2009

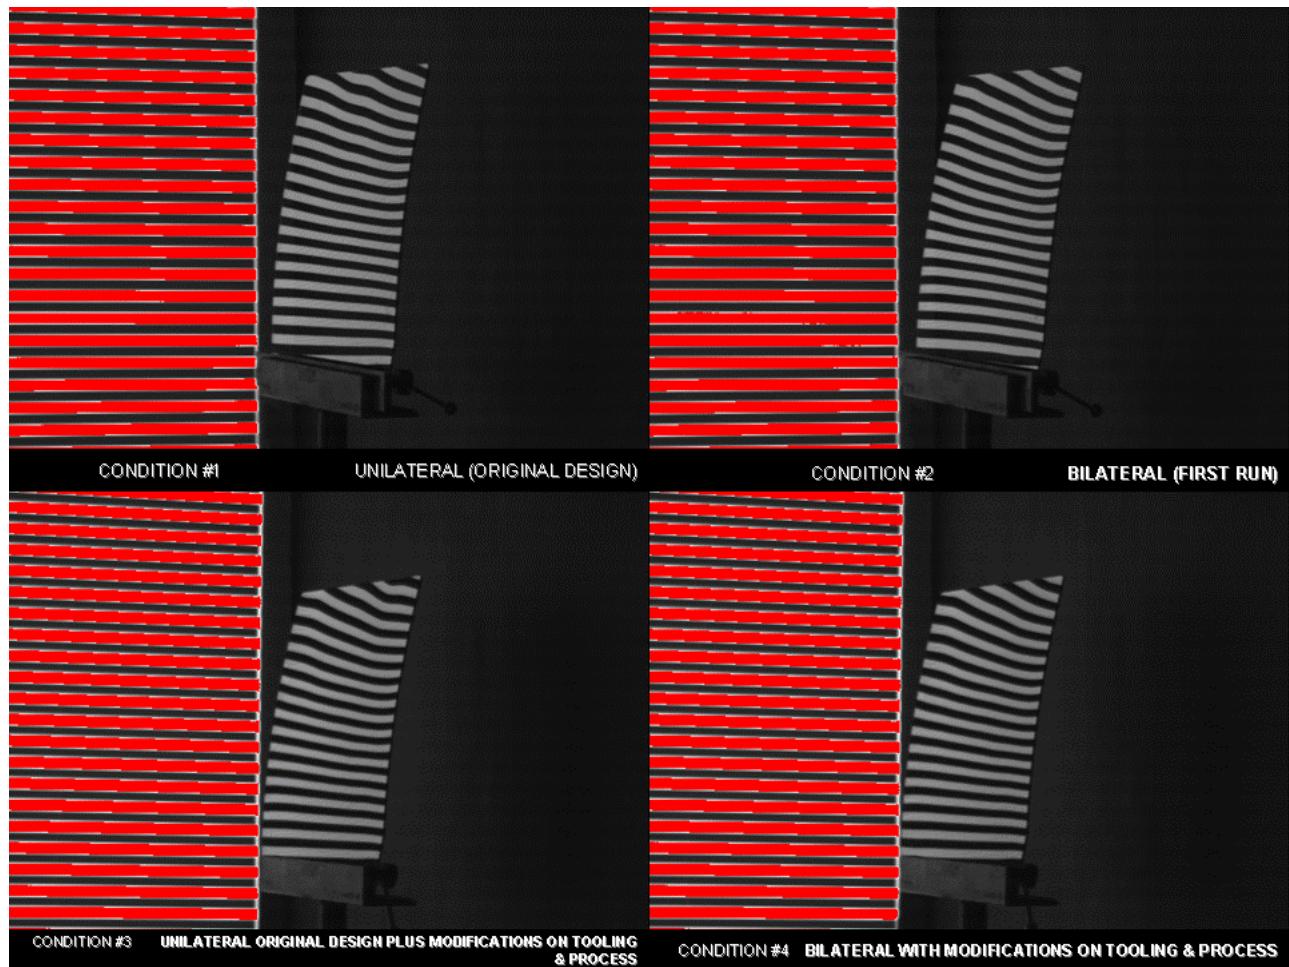
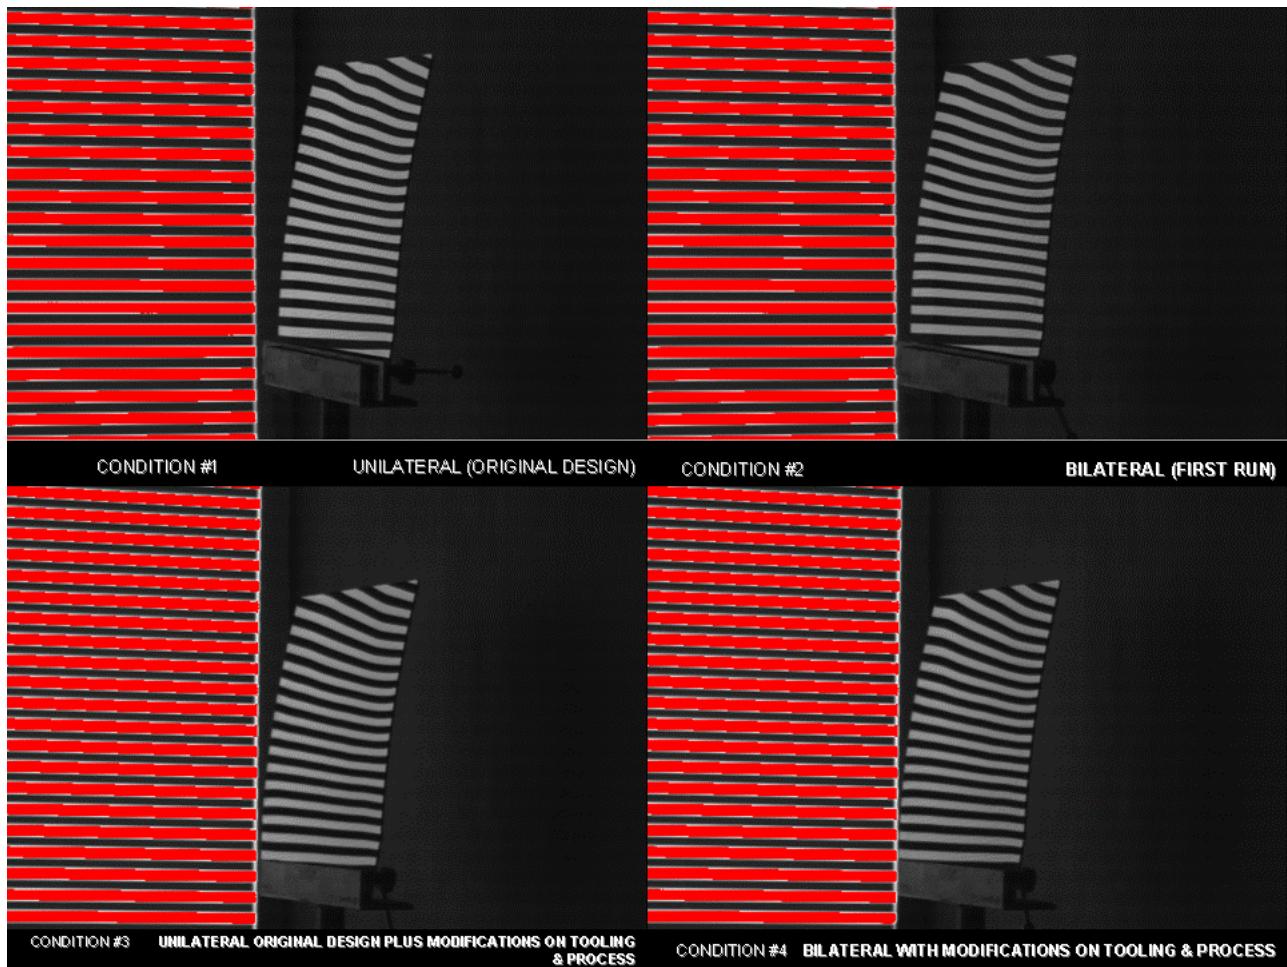
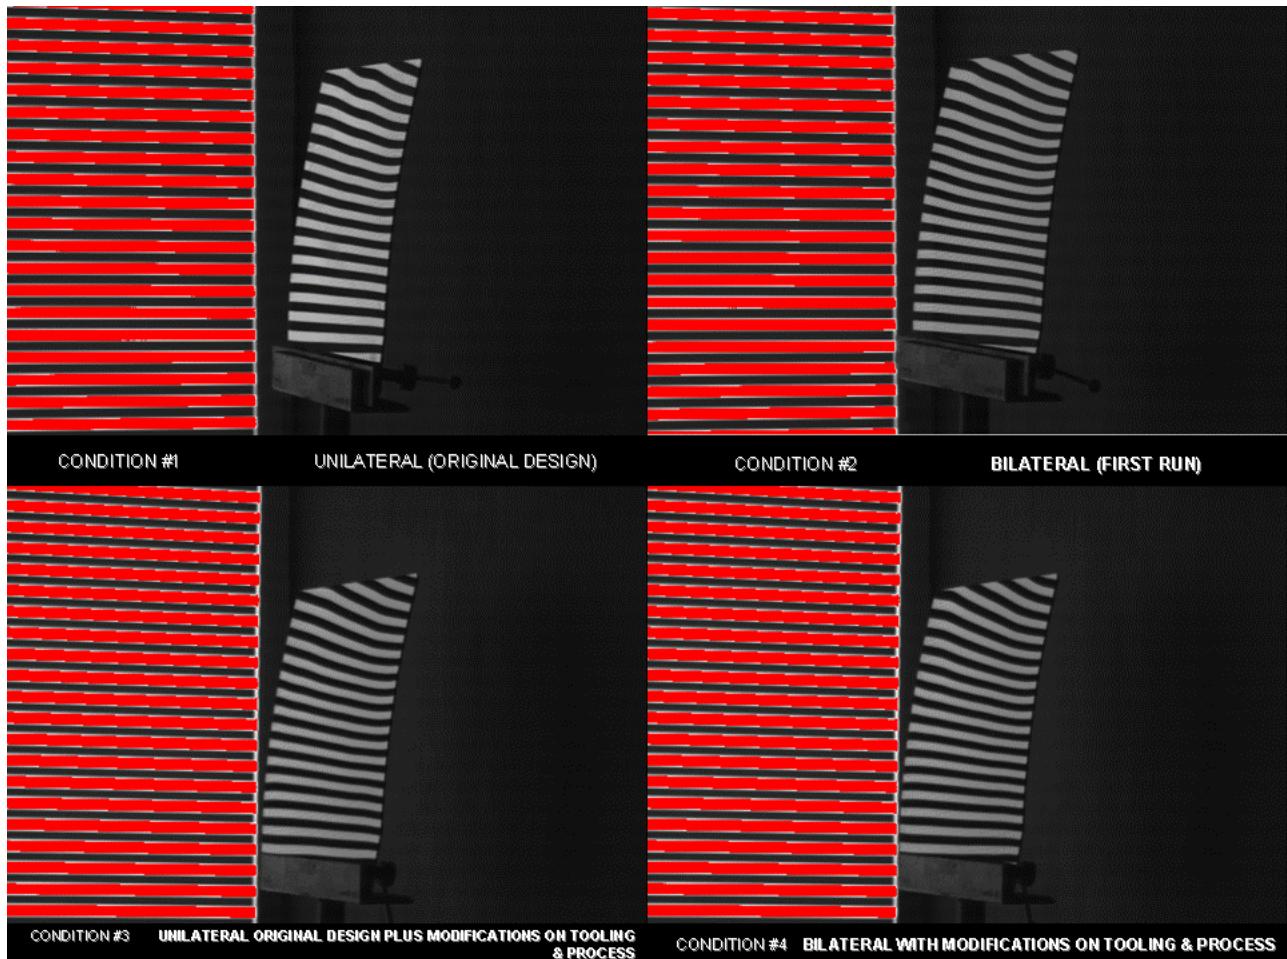
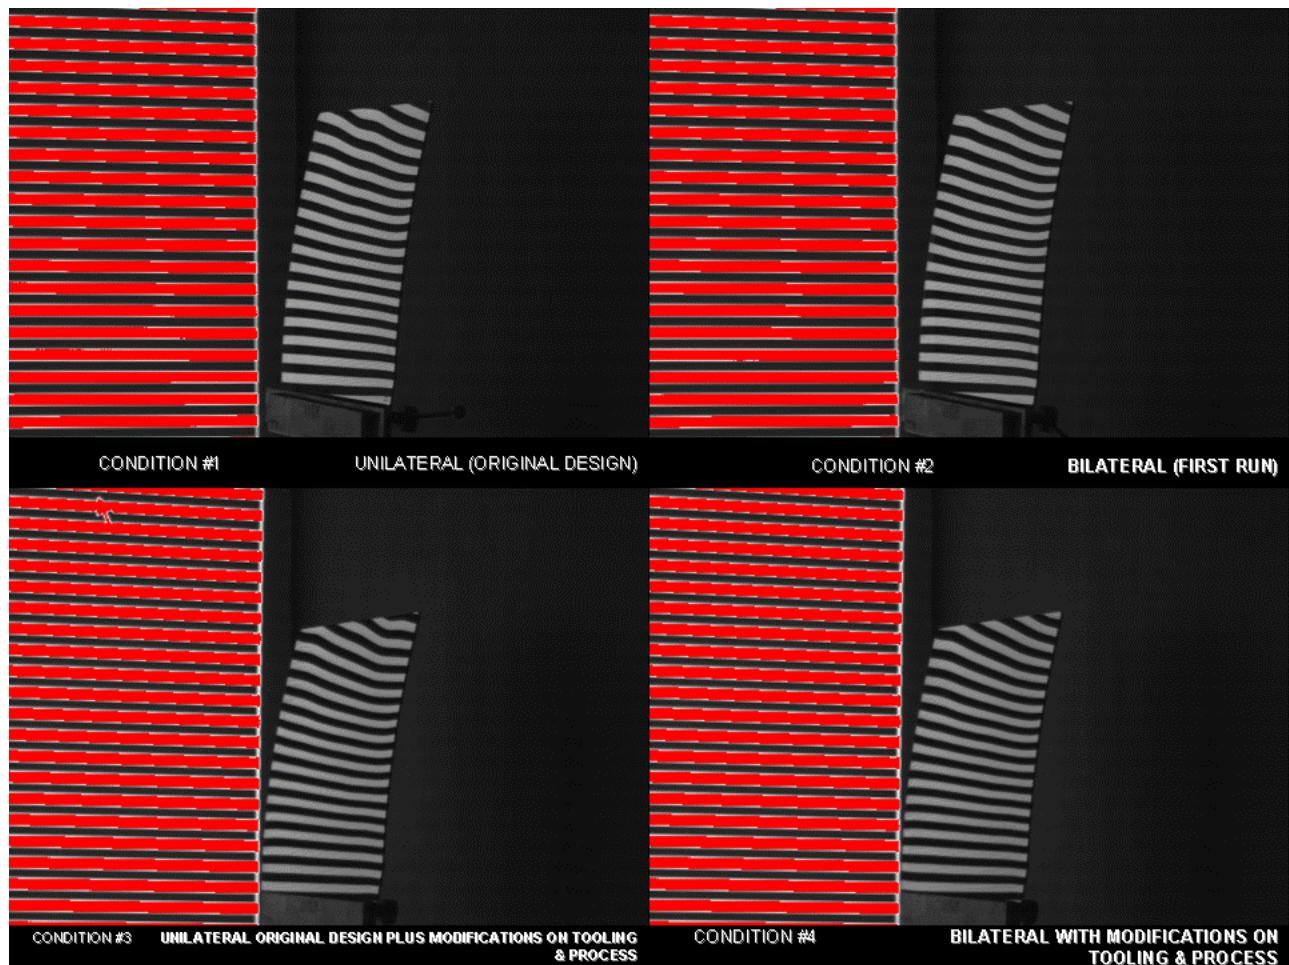
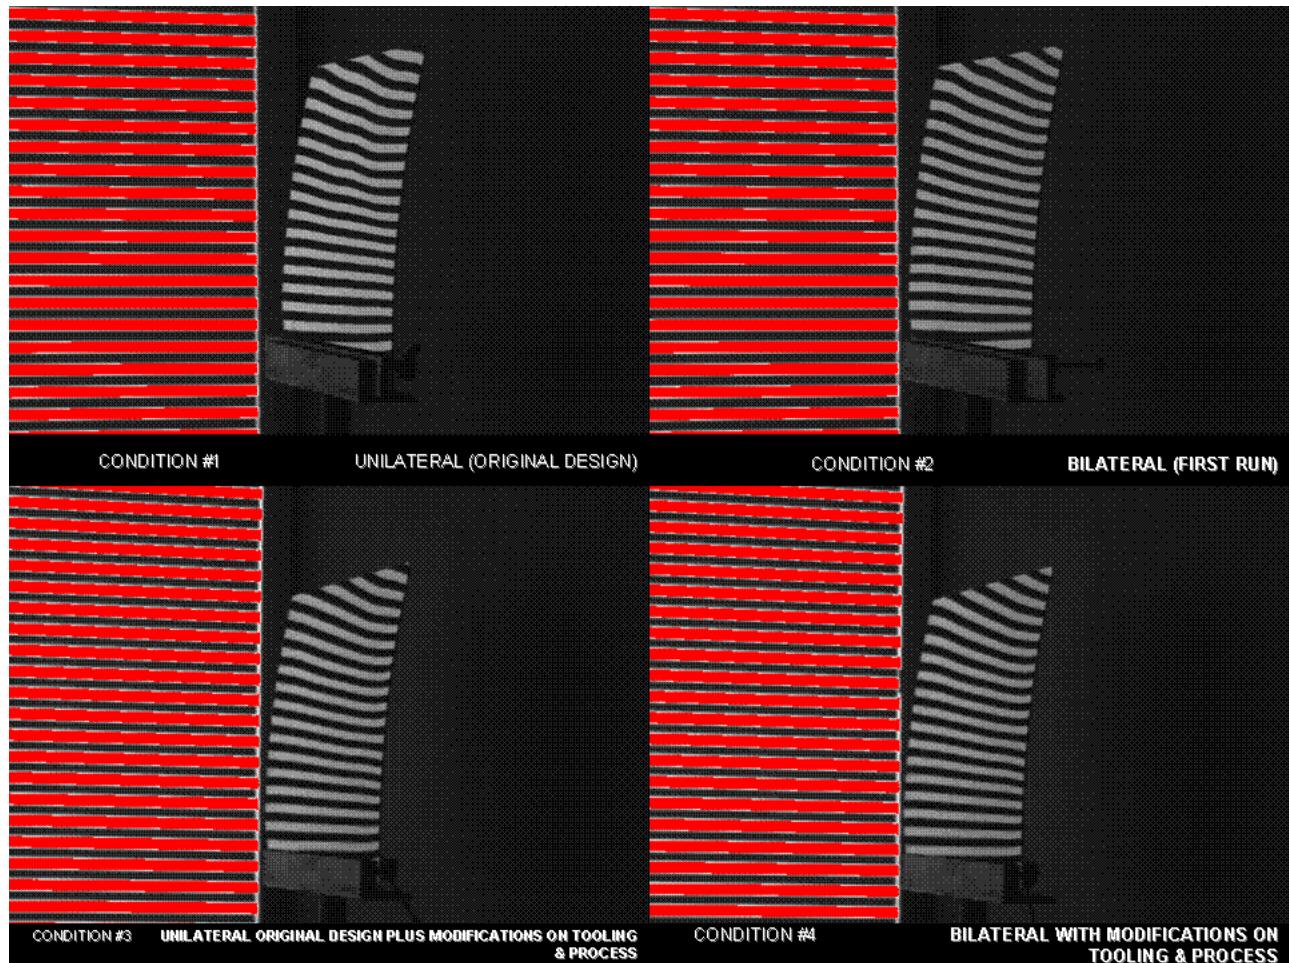
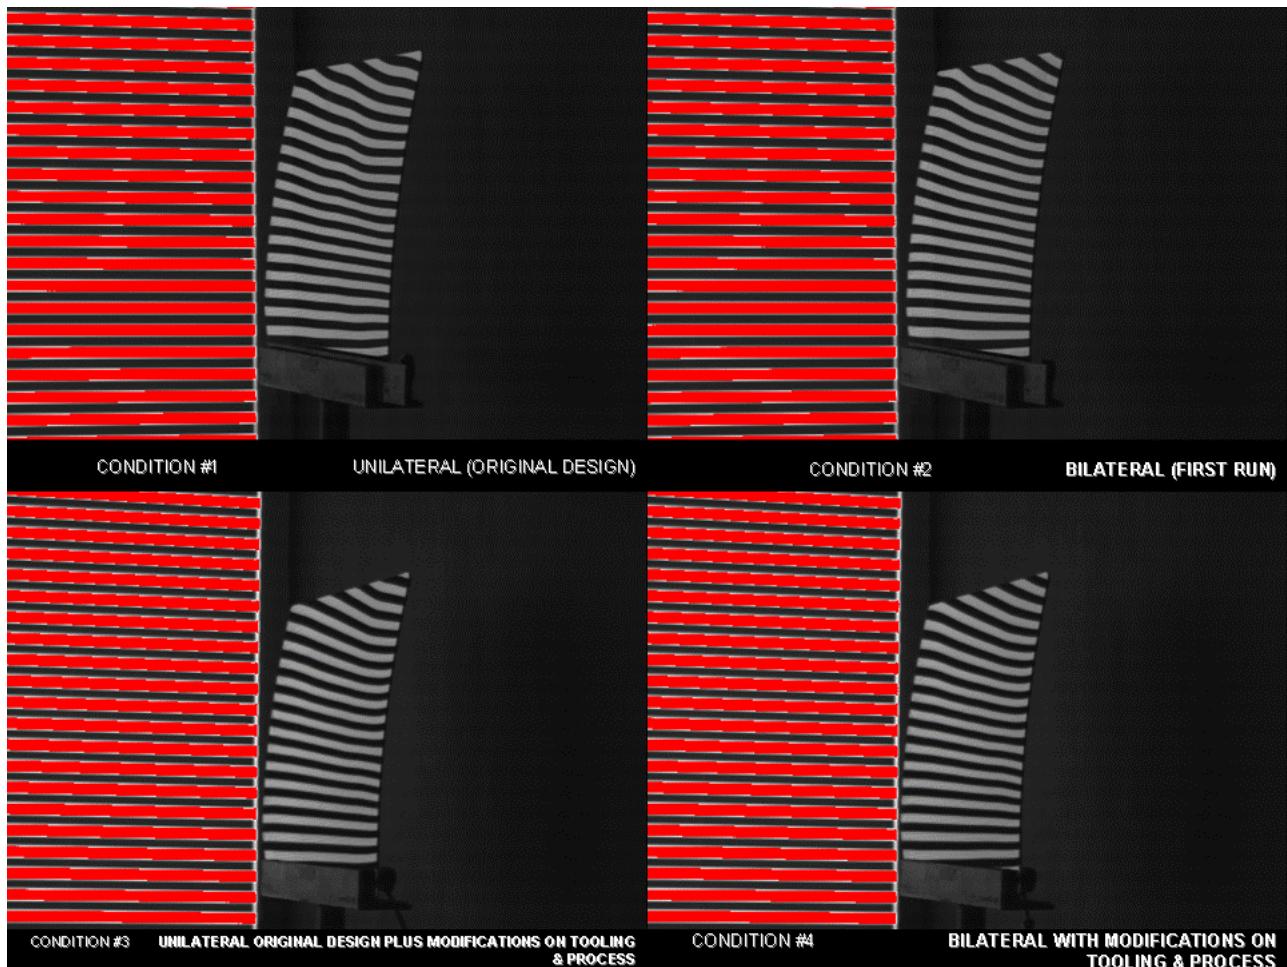
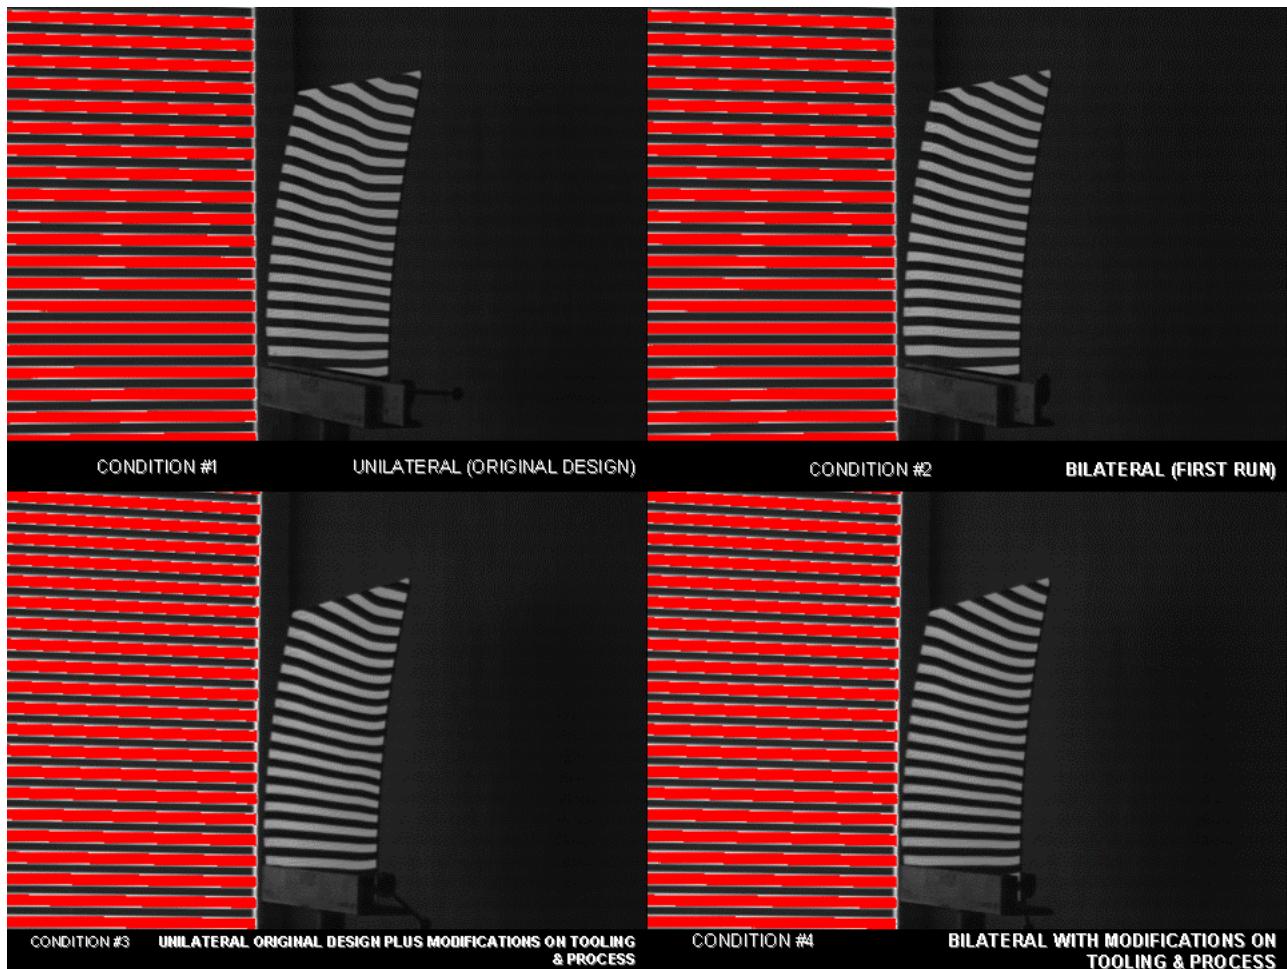
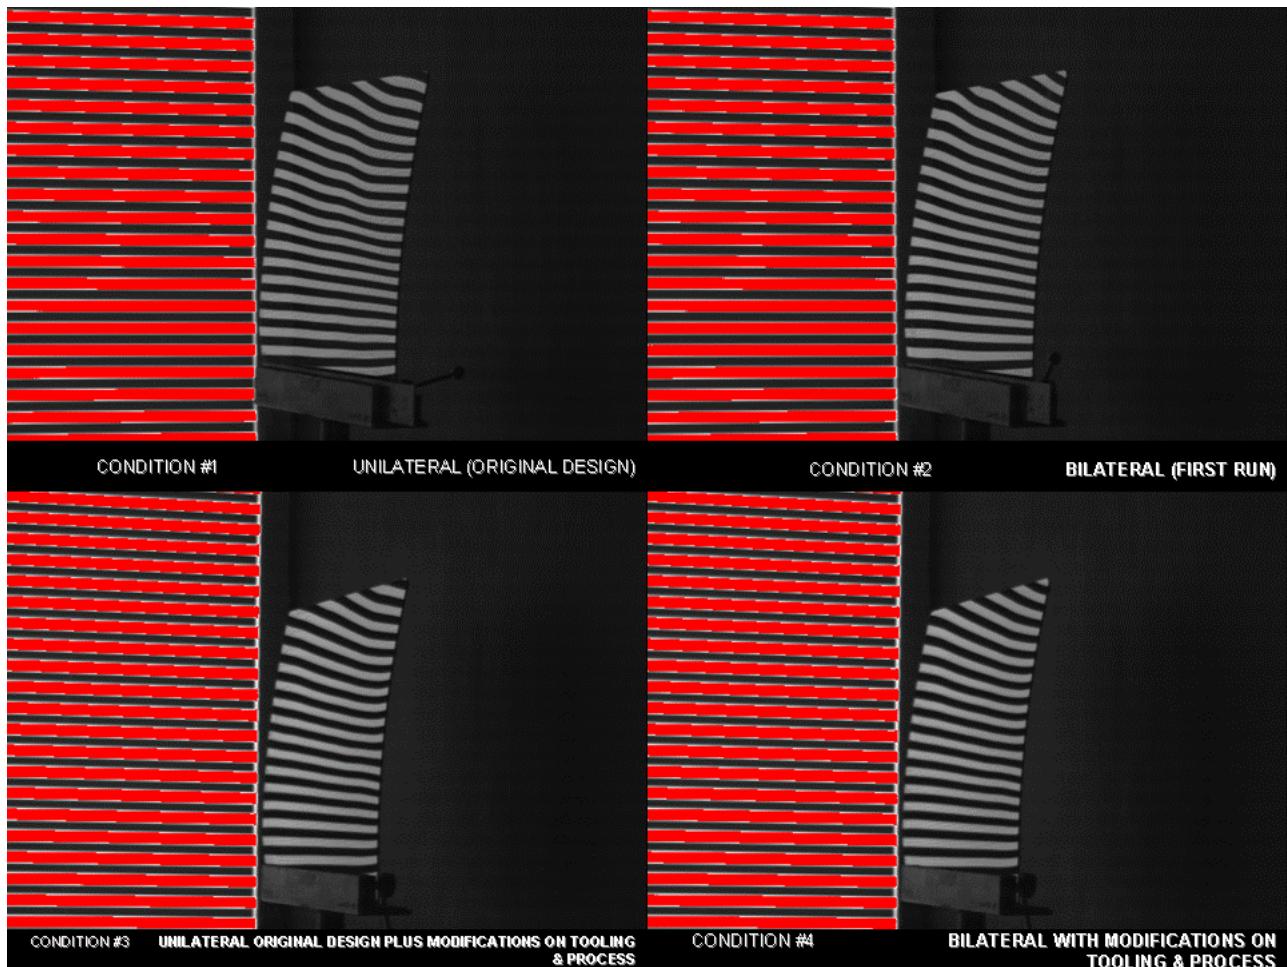
D471 Rear Door DISTORTION PICS: LEFT HAND (First Parts)

The lowest Reflective Distortion showed on pictures taken demonstrates again that Condition #4 are the one that reduce it considerable. Nevertheless Condition #3 even Condition #2 also gives a better Reflective Distortion reduction compare with the original design parts. These results have the same tendency for Rear Doors and Front Doors.

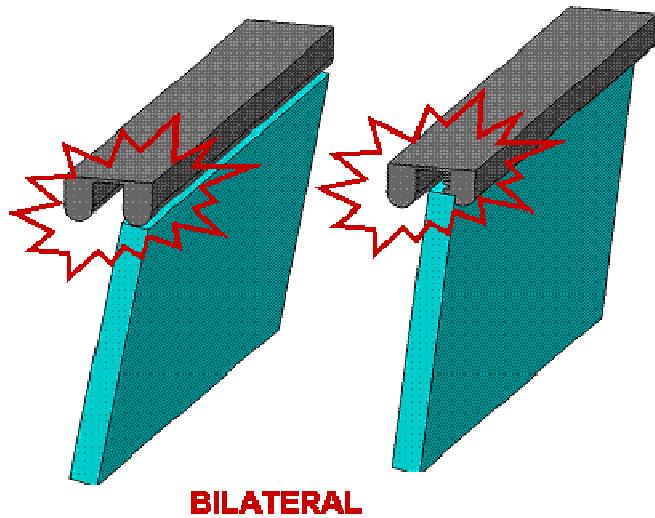
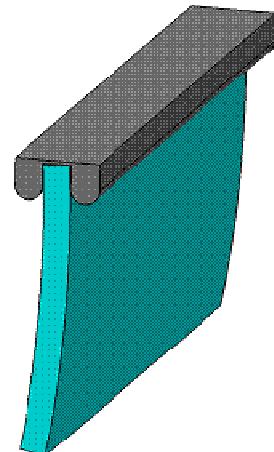
The unsuccessful TRIAL describe before automatically took out the Option of Condition number 2 and 4.

In order to give FORD the best option to get their Approval, a combination between Condition 3 and 4 was suggested. The FORM specification on Top Edge was modified. Besides to be controlled as an unilateral tolerance the whole edge, a ROC specification was determined along the top edge having a central point classified as a SC with +0/-2 mm. This single point will remain unilaterally so that the glass ensures to have a good performance going inboard into the run channel.

This modification will allow the part to have a softly transition from pillars to Top edge avoiding to have a critical deformation due to Unilateral Top Edge. That softness will shows a significant Reflective Distortion similar than the one resulted by parts with Condition number 4.
